# **HOME REPORT**

FLAT

1A GROUND FLOOR RIGHT THE GLEBE

Property address	FLAT, 1A GROUND FLOOR RIGHT THE GLEBE, MAIN STREET, ST NINIANS, STIRLING, FK7 9AN
Customer	Mr Gordon Wilson
Customer address	
Prepared by	DM Hall LLP
Date of inspection	22nd March 2024

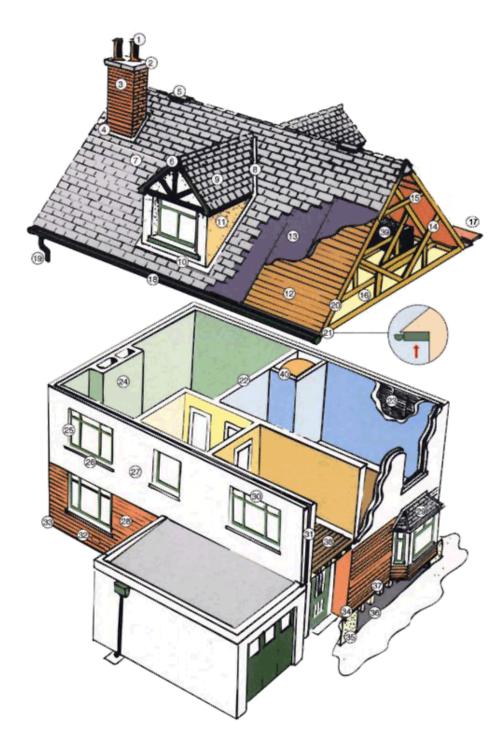
# Sectional Diagram showing elements of a typical house

Reference may be made in this report to some or all of the above component parts of the property. This diagram may assist you in locating and understanding these items.

- 1) Chimney pots
- 2) Coping stone
- 3) Chimney head
- 4 Flashing
- 5 Ridge ventilation
- 6) Ridge board
- 7) Slates / tiles
- 8 Valley guttering
- Dormer projection
- 10 Dormer flashing
- 11) Dormer cheeks
- (12) Sarking
- (13) Roof felt
- (14) Trusses
- (15) Collar
- 16 Insulation
- 17) Parapet gutter
- (18) Eaves guttering
- 19) Rainwater downpipe
- 20) Verge boards/skews
- 21) Soffit boards
- 22) Partition wall
- 23) Lath / plaster
- 24) Chimney breast
- (25) Window pointing
- 6) Window sills
- 27) Rendering
- (28) Brickwork / pointing
- 29) Bay window projection
- 30 Lintels
- (31) Cavity walls / wall ties
- 32) Subfloor ventilator
- 33 Damp proof course
- 34) Base course
- (35) Foundations
- 36) Solum
- 37) Floor joists
- 38) Floorboards
- (39) Water tank
- 40) Hot water tank
